FINAL REPORT  
AUGUST 1993

REPORT NO. 93-23

TOW MISSILE PALLET  
MIL-STD-1660 TESTS

U.S. ARMY  
ARMAMENT  
MUNITIONS  
CHEMICAL COMMAND

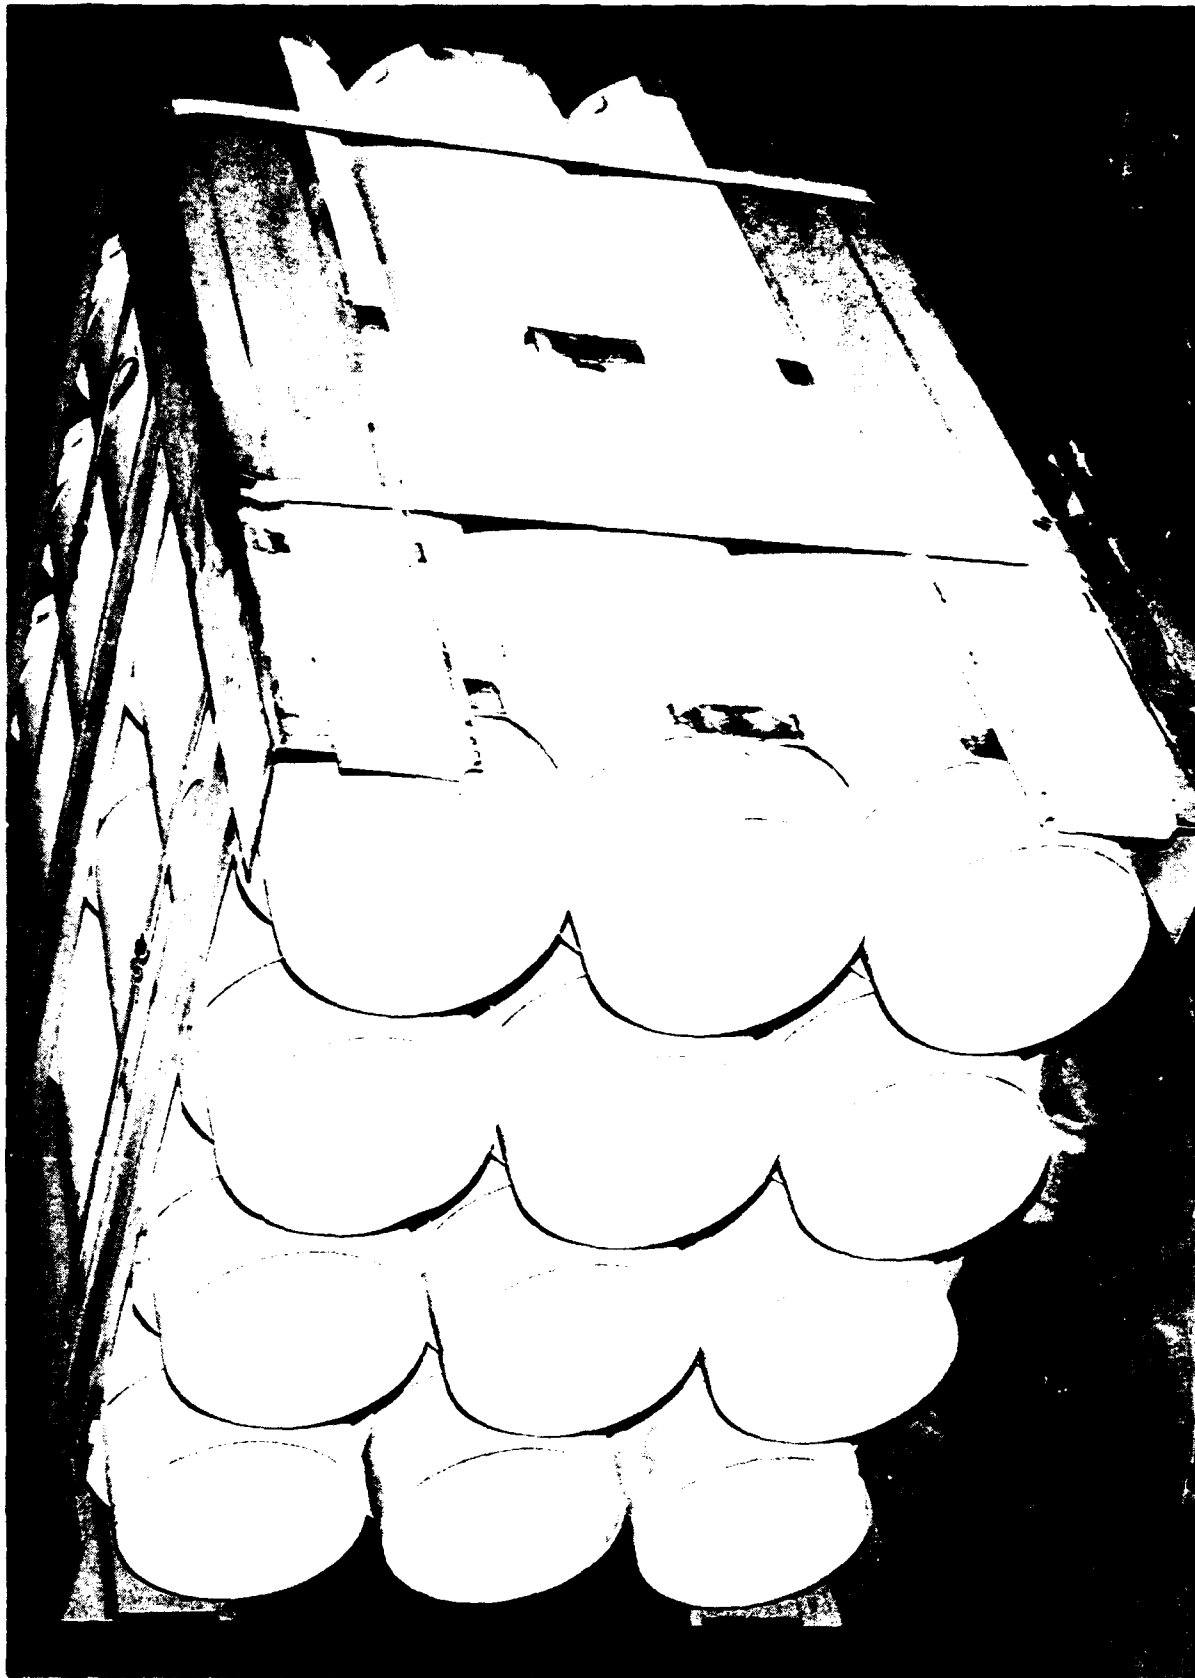
PHOTO NO. SPN 93-250-4570: This photo shows an overall view of the TOW missile pallet.

C. **OBJECTIVE**. The objective of this series of tests was to ascertain the TOW missile pallet and container would not be damaged during transportation (see part 6, pages 6-2 through 6-4).

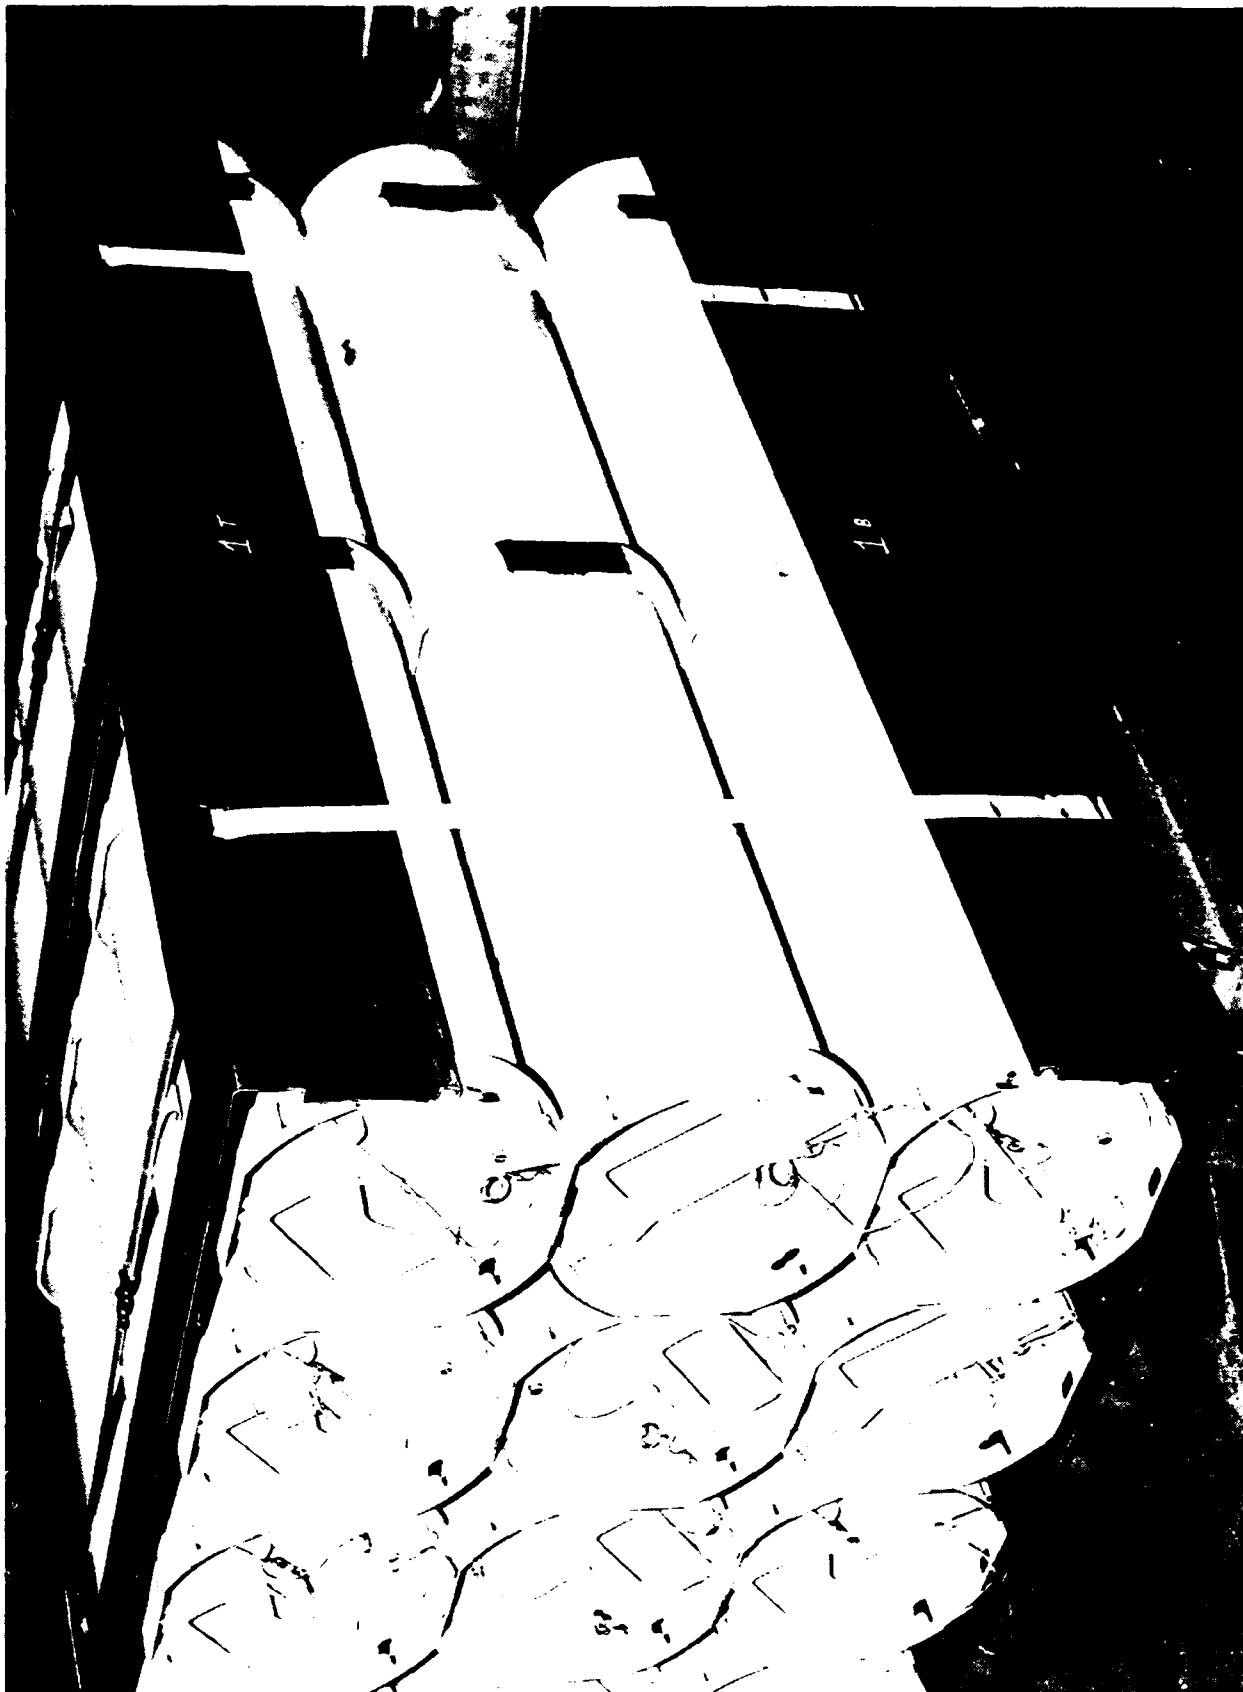
PHOTO NO. SCN 93-250-4502: This photo shows an overall view of the TOW missile pallet.

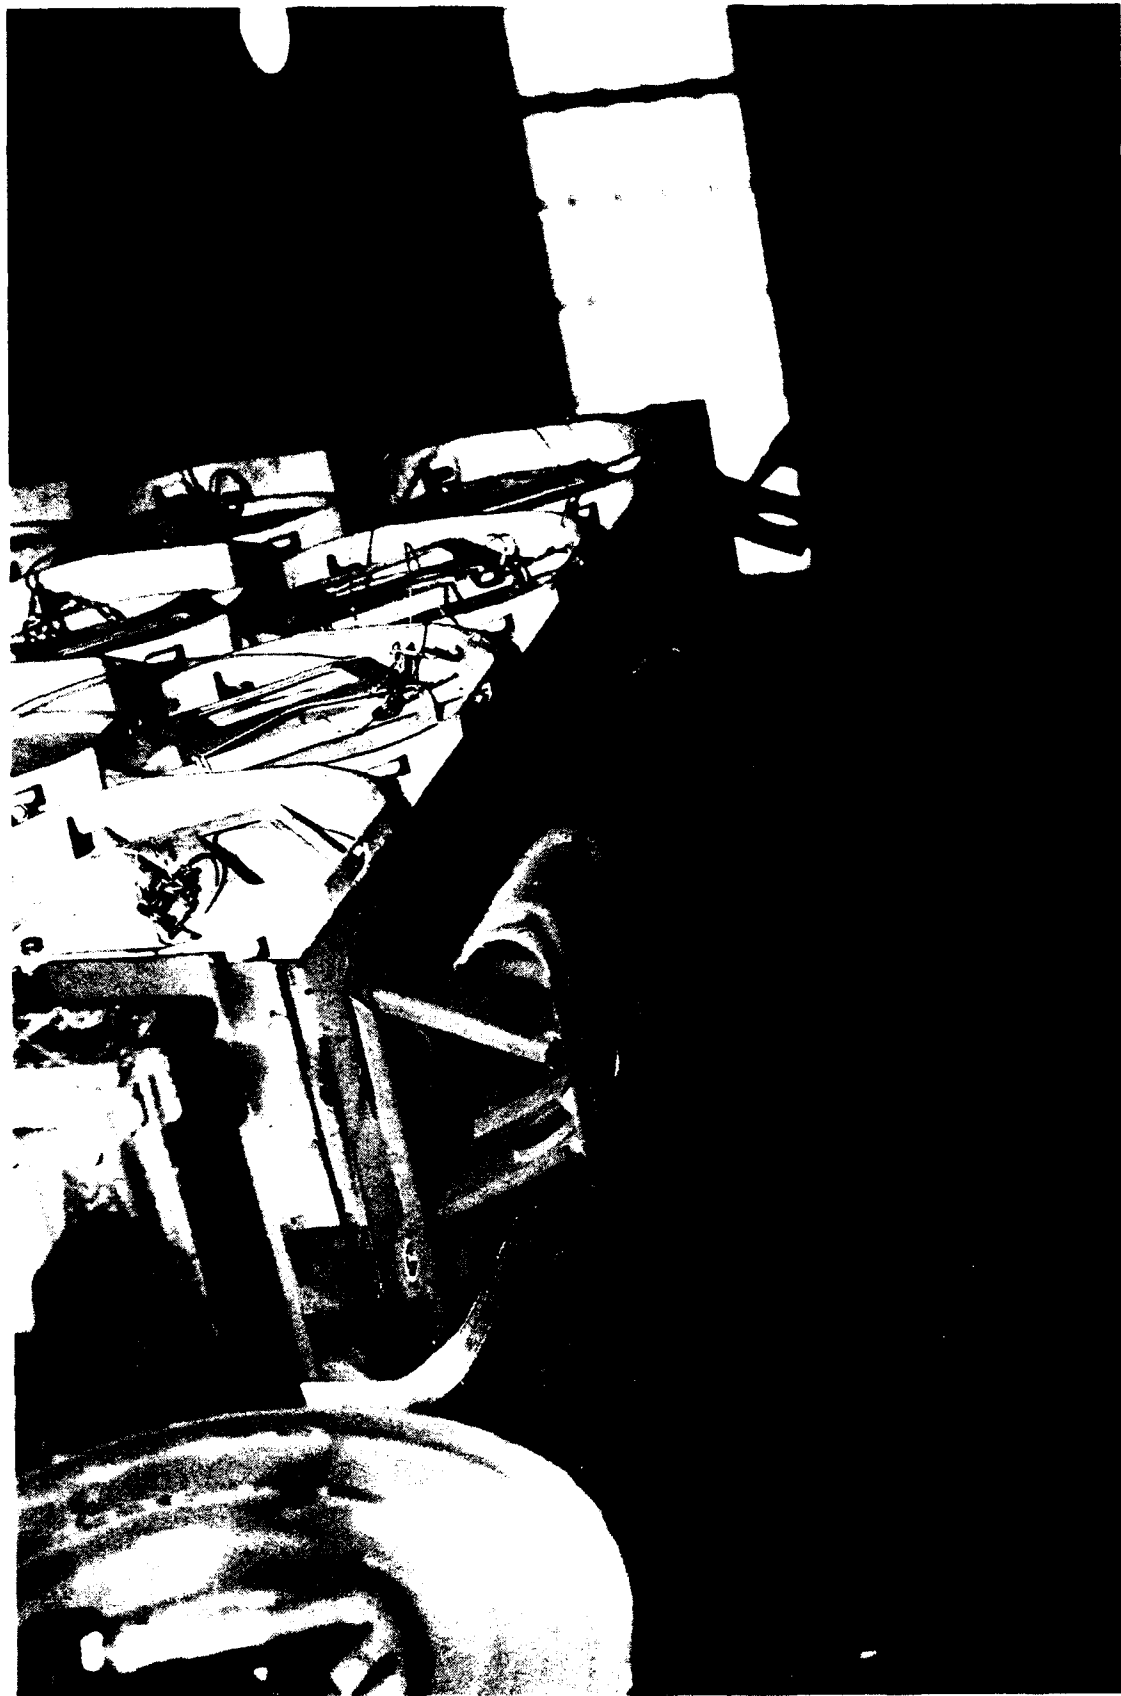
PHOTO NO. SPN 93-250-4567: This photo shows the location of the bottom adapter relative to the pallet as an example of what to avoid. This orientation caused excess cracking of the pallet deck.	
--	---	--

Slight cracking of the pallet deck occurred on the fifth and sixth pallet loads; however, the damage was minimized with the design changes made in the preceding tests. The final design had the front and rear cross members of the bottom adapter centered on the pallet, thus, the load bearing surfaces of the containers were centered on the pallet. This minimizes damage to each end of the pallet by avoiding excess cantilevering.

E. END OF TEST INSPECTION. The overhang on the front of the pallet was alleviated; however, the extra weight over the front posts caused one front post to break through the pallet deck. To alleviate the problem, the bottom adapter was shifted 7/8-inch forward.

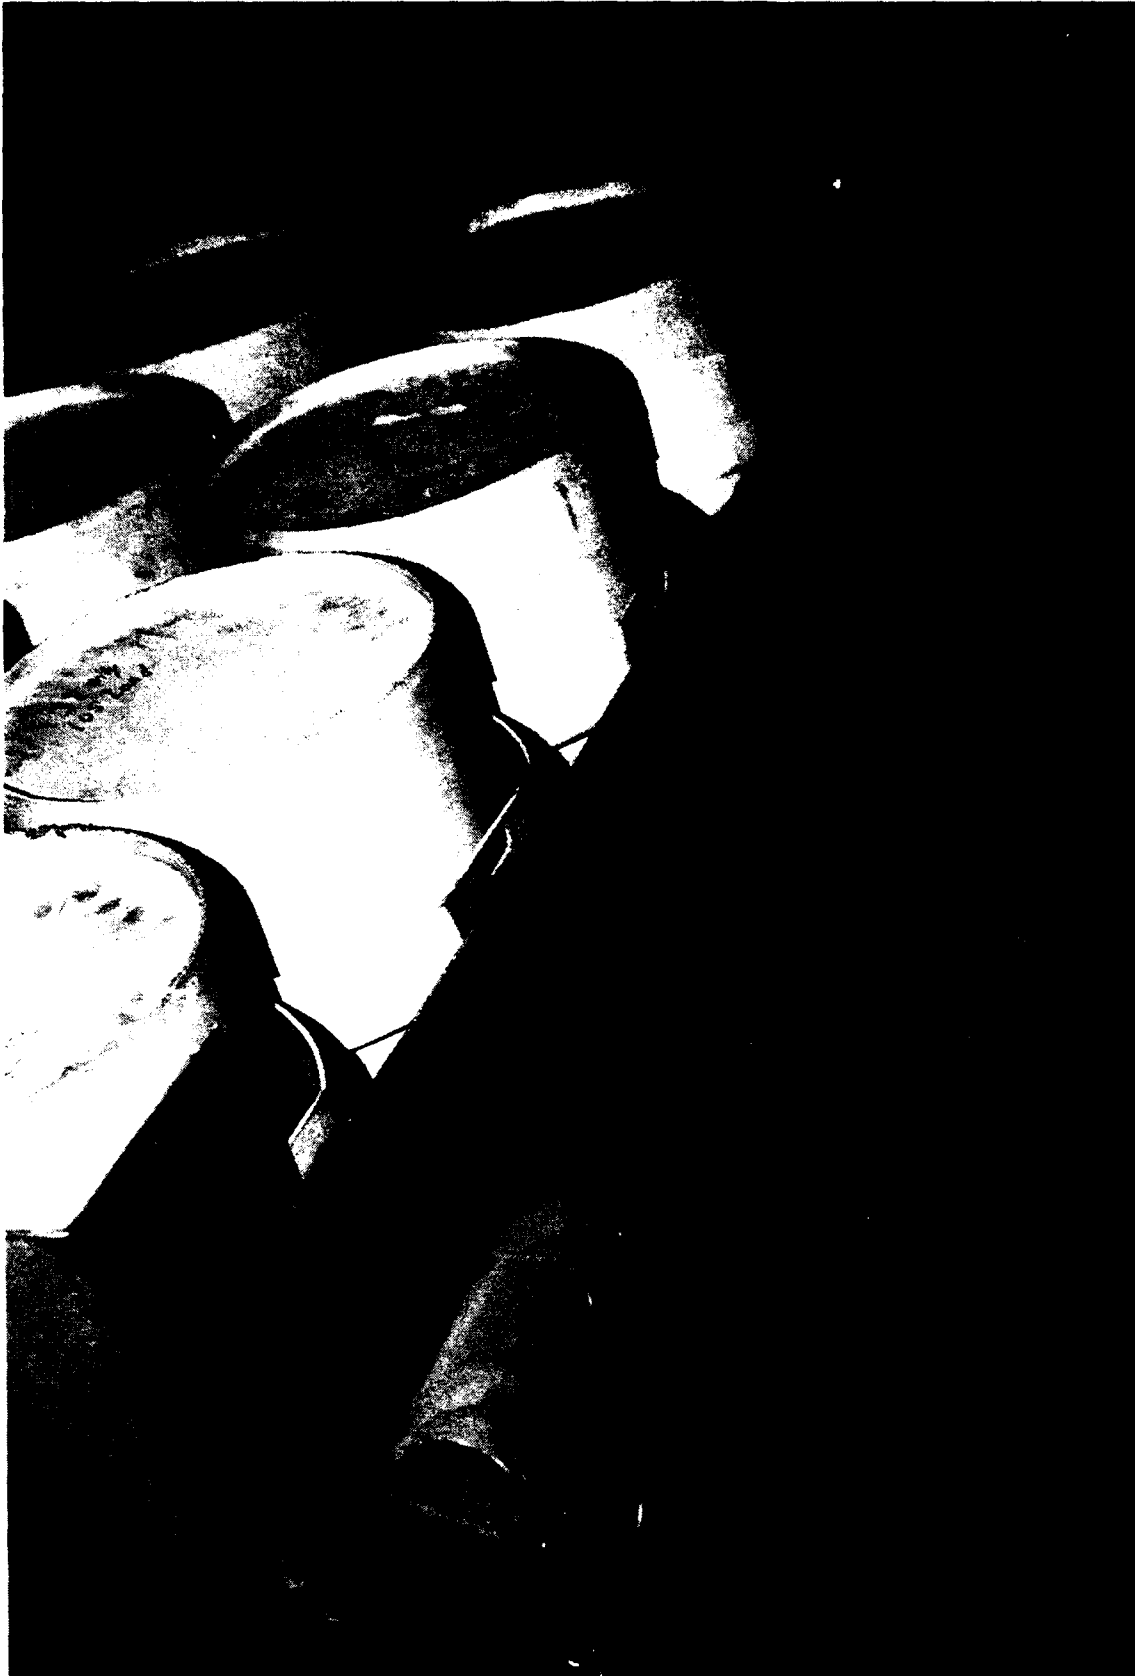
PHOTO NO. SPN 93-250-4566: This photo shows the location of the bottom adapter relative to the pallet as an example of the correct orientation.

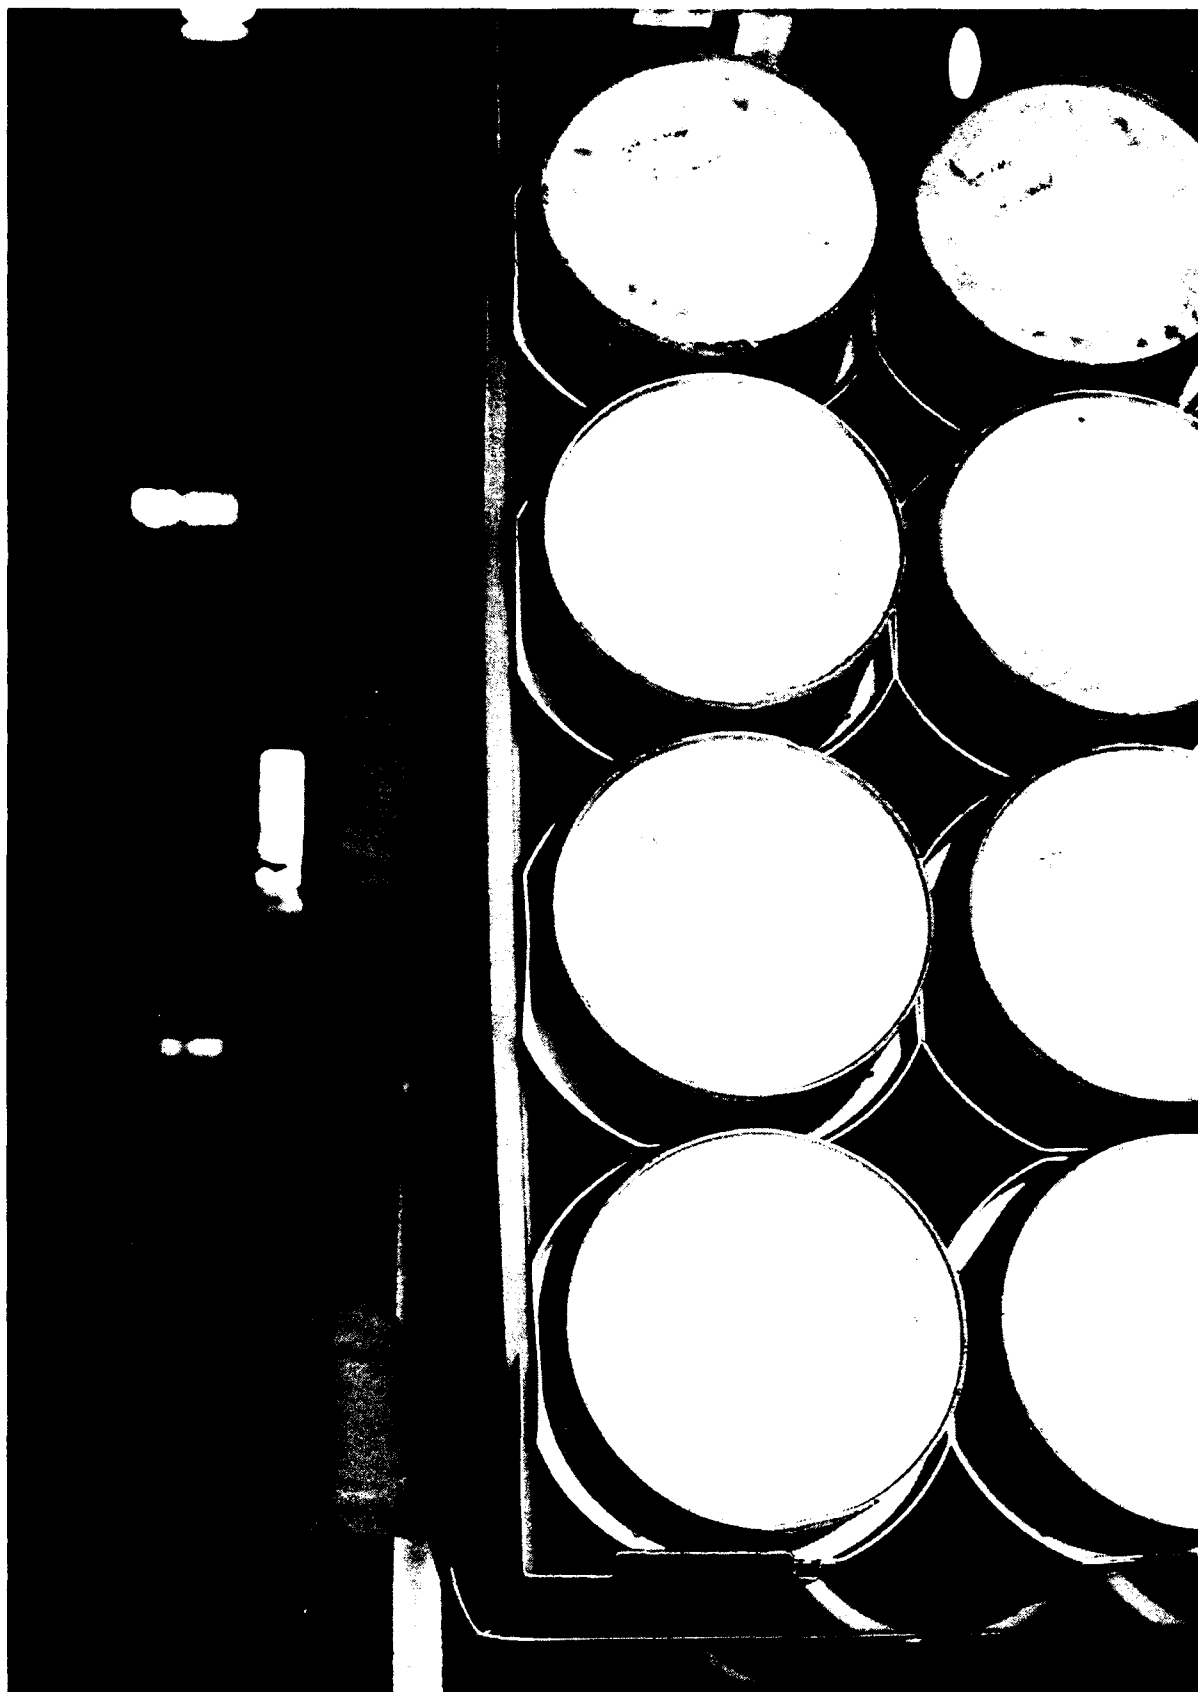
PHOTO NO. SPN 93-250-4564: This photo shows the location of the bottom adapter relative to the pallet as an example of the correct orientation. Note the flexibility introduced by the bottom adapter.
